WRIGHT GROUP INC.

Scott Blake

250 Edwards Boulevard
Lake Geneva, WI

INTRODUCTION:

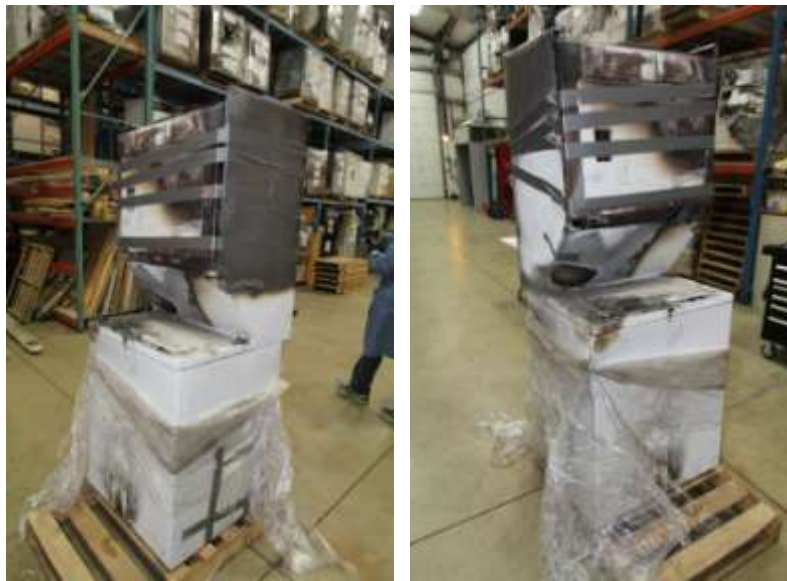
Subject Laundry Center

The exterior of the dryer portion displayed fire patterns on the top, left and front sides. The dryer door had exterior fire patterns and the plastic door handle was missing. Fire patterns were concentrated to the left front corner of the cabinet, where the interior plastic components had been consumed. The rear of the dryer displayed soot damage where the edges of the cabinet and rear wall met. Both the louvered access panel and the cover for the power cord connection had been removed post-fire during the prior evidence examination. The front panel had also been removed previously and was held in place using duct tape at the time of this inspection.

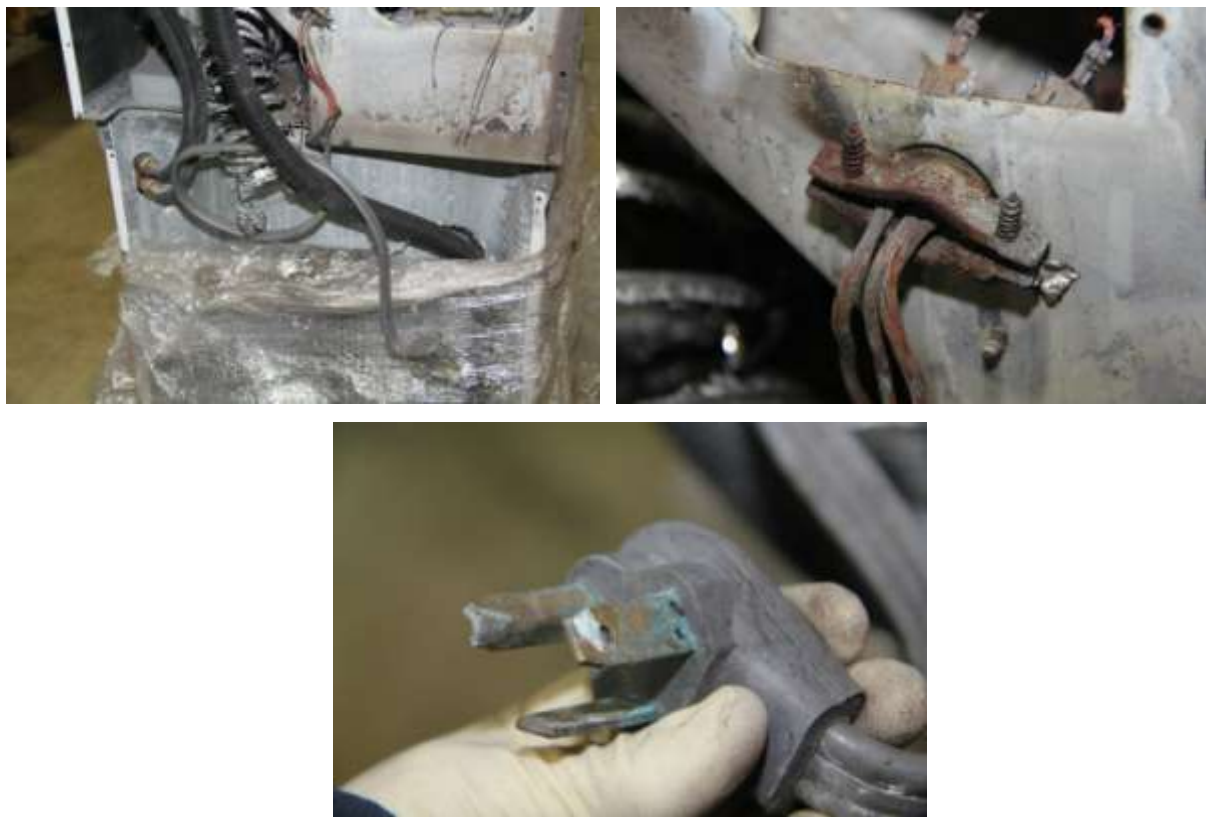
Power Cord

The 3 wire power cord was routed through the power cord opening and was equipped with a strain relief device. Localized fire damage was observed on insulation of the power cord where it entered the cabinet. The power cord connection cover was previously opened and the power cord was found properly wired to the appliance. There was no sign of electrical activity or overheating on the power cord or at the connection.

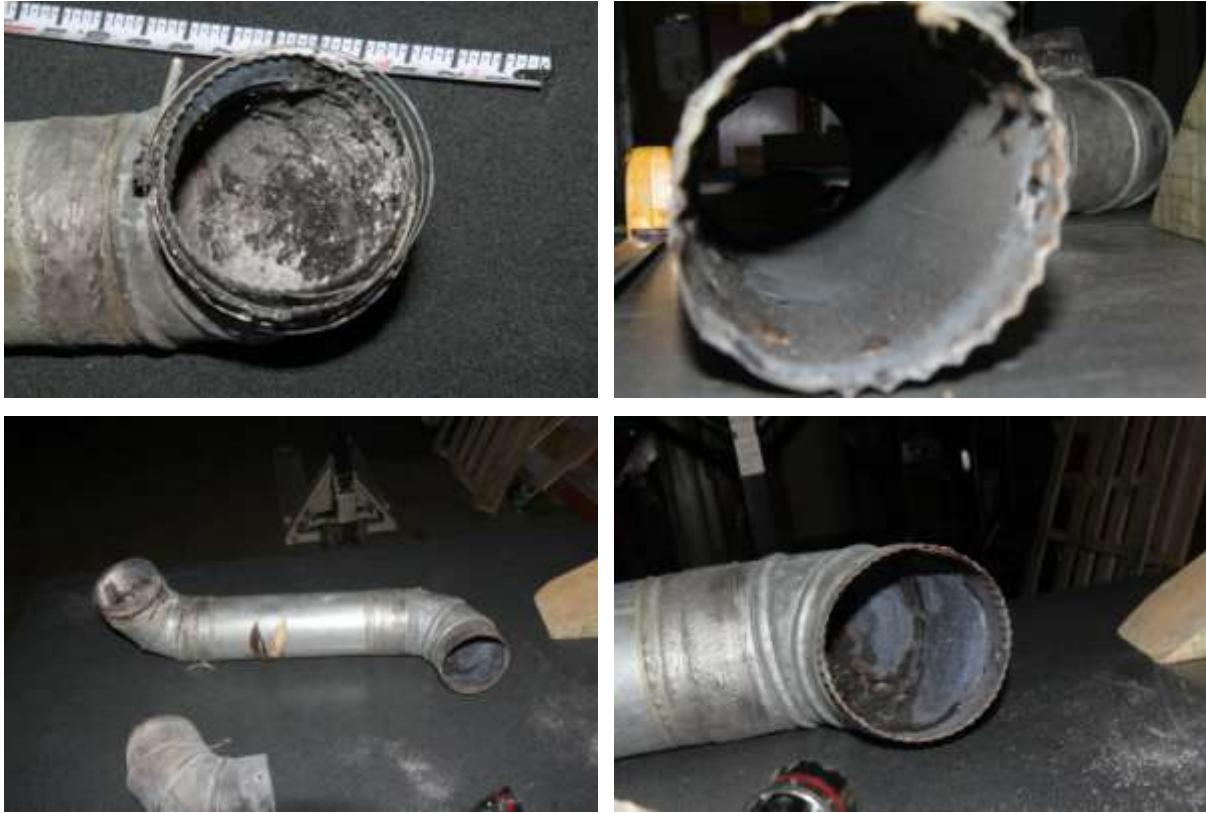
Venting Components

A portion of the venting had been included with the evidence. It consisted of a combination of flexible foil and rigid permanent ducting. Eighteen coils of flexible foil ducting were connected to the dryer. The flexible foil ducting was still clamped to the dryer at the time of this inspection. There were not any remains of lint in the flexible foil or the internal dryer duct. The permanent ducting consisted of approximately 4 feet of rigid metal duct, comprised of two straight sections and three 90 degree rigid metal elbows. When reconstructed in its original positioning, it totaled approximate 4 ½ feet in length. A very slight amount of lint was observed in the permanent ducting. The elbow that would have been positioned within the laundry closet closest to the vent connection at the rear of the appliance was equipped with a couple coils of wire from the flexible duct, connected via a band clamp. Charred lint was seen at the 90 degree elbow that was attached to the flexible foil duct. The venting was not arranged in the same form that the employees of Blake Capital recalled in their depositions, with rigid venting extending further down into the laundry closet than ceiling level. This indicated the permanent duct connection was at approximately the same height as the vent connection on the rear of the appliance. This allowed that the flexible foil was in its shortest length possible. The remainder of the permanently installed duct system in the attic was not collected or documented in any information provided to the Wright Group to date.

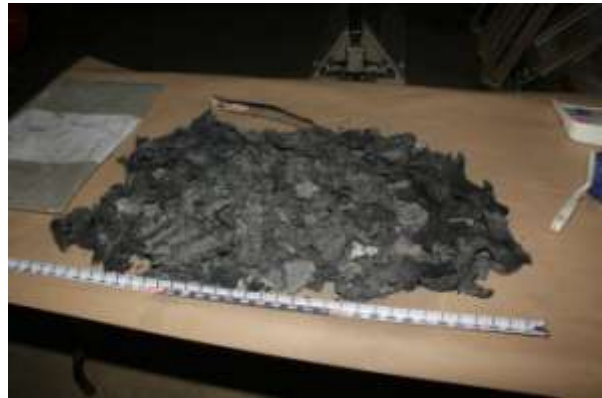
Dryer Load

Examination of the drum opening and door of the dryer revealed both were directly fire damaged, with the concentration of fire patterns emanating from the area of the trap duct and blower housing at the left front corner. The interior of the door displayed heavy oxidation and the door gasket and label on the interior of the door had been entirely consumed. The door latch and door switch had both been heavily fire damaged, and the door latch was no longer securing the door. The lint trap and filter had been consumed. The dryer load, found previously secured in a plastic bag, was heavily fire damaged. The drum was rotated post fire and the visible load line had shifted.

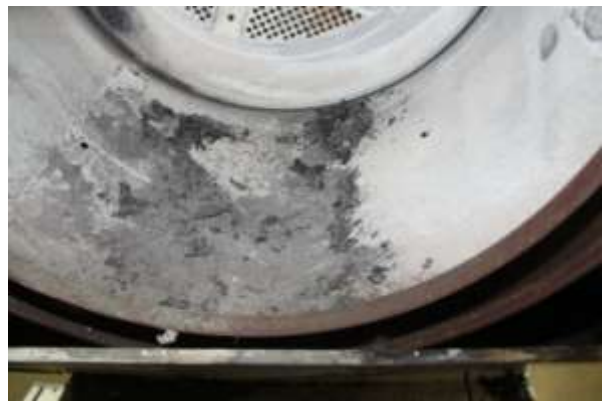
Interior of the Drum

The interior of the drum also displayed heavy fire damage and the drum paddles had been entirely consumed. Fire patterns observed in the drum were not consistent with the fire originating in the load, but rather that the drum was attacked by fire from the plastic blower assembly and trap duct below and to the left.

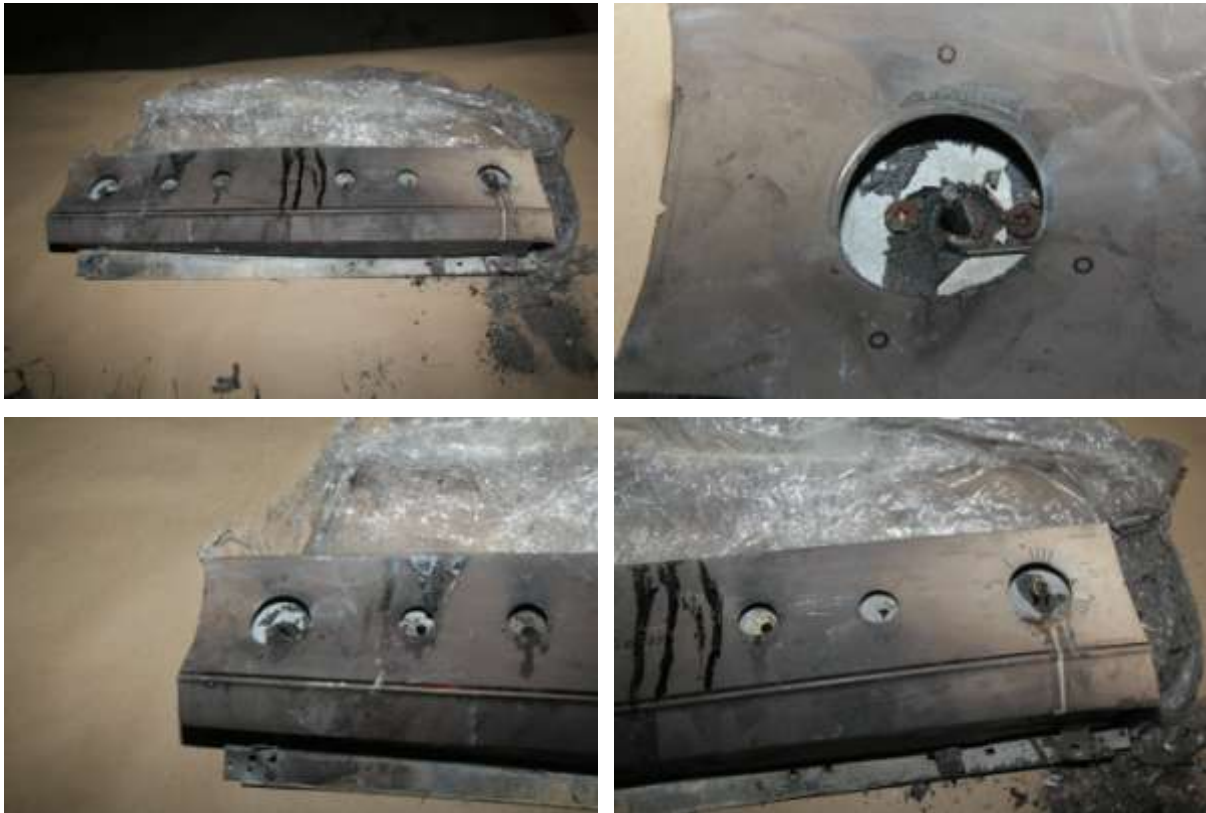
Control Console & Switch Positions

Examination of the control console at the front of the appliance revealed that it was detached and burned from the inside outward. The fire damage was concentrated at the left side, from the former location of the trap duct and blower housing. The control knobs were missing from the switches. The timer shaft had broken in the fire and could not be tested to determine its setting at the time of the fire. The console was labeled with the Frigidaire Gallery name.

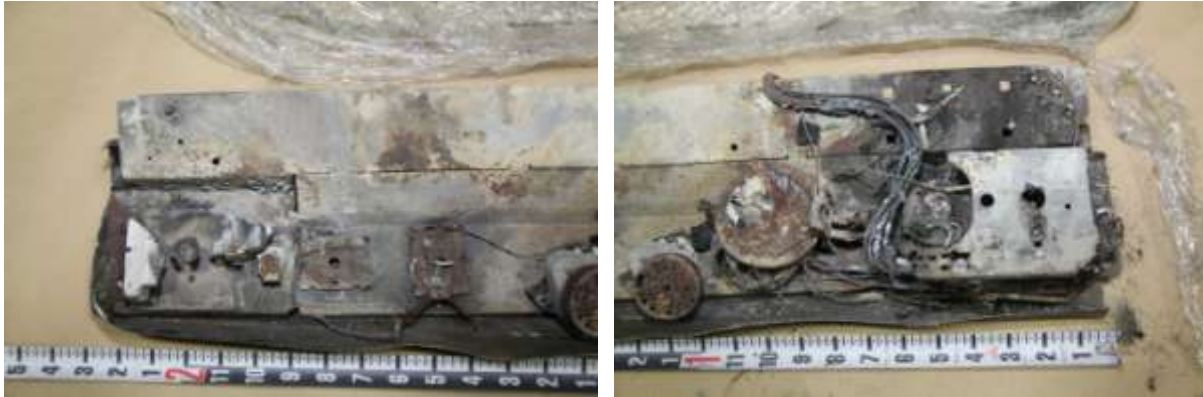
Interior of Control Console

The control wiring displayed burned and consumed insulation throughout the controls. A loose wire had been previously secured and bagged with evidence with the control console. Electrical activity was observed on these wires.

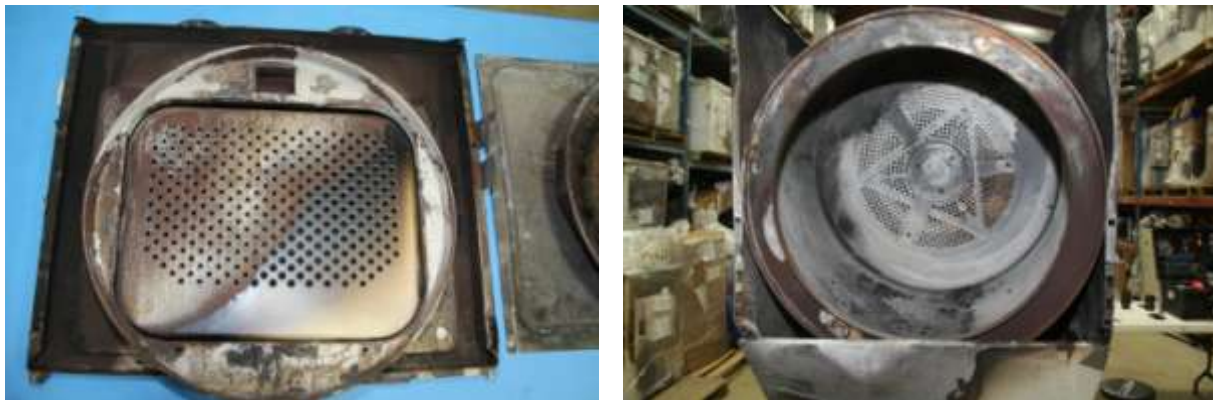
Front Panel Removed

The front panel of the dryer was disassembled and the drum was removed allowing access to the interior of the dryer portion of the appliance. The interior of the front panel was examined. Heavy oxidization was observed to the interior side and the plastic trap duct and blower housing had been consumed.

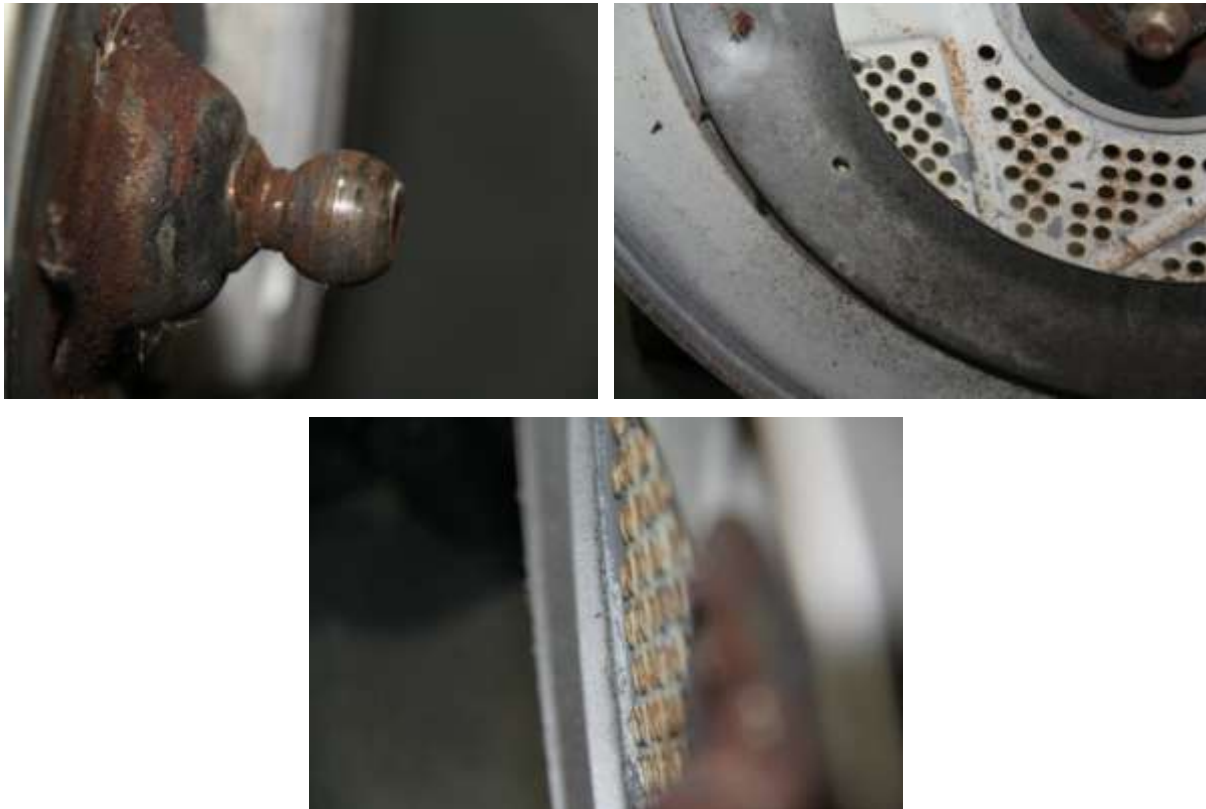
Lint on the Rear of the Drum

The drum was removed and the deflector attached to the rear of the drum contained no unburned or charred lint. Due to the extensive fire damage, it is likely that any lint that was accumulated on the rear of the drum and within the baffle had been consumed during the fire. Our testing and analysis of these Ball-Hitch dryer fires reveals that lint accumulates on the rear of the drum in every dryer, even those properly installed and operated under reasonably foreseeable conditions, with the amount dependent on individual variables. Examination of the baffle and rear of the drum revealed no evidence of electrical activity from contact with the heating element. The ball pivot was examined and was undamaged.

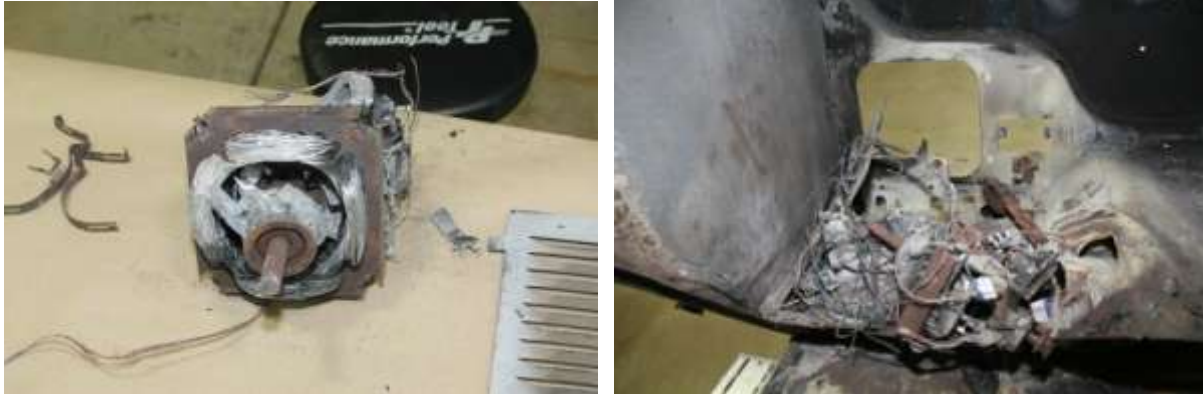
Motor

Examination of the dryer motor revealed that it had shifted from its original position within the dryer. The aluminum frame was melted and the motor windings had been damaged during the fire. The shaft was seized and could not be rotated. The centrifugal switch was intact and manually operated. No electrical activity was observed on the motor or the attached stranded copper conductors of the wiring harness. The motor and its associated wiring and components were eliminated as potential ignition sources.

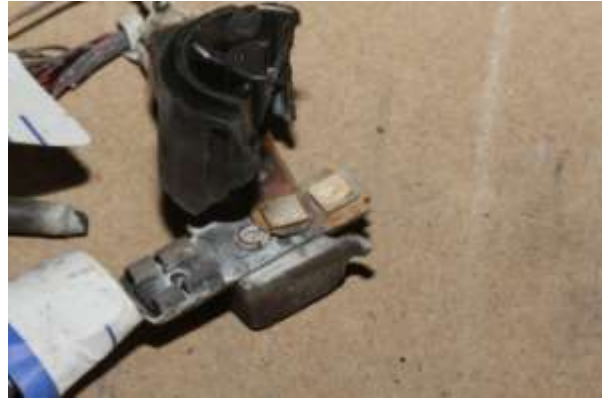
Operational Thermostat at Blower Housing

The plastic fan and blower housing had been completely consumed during the fire. The operational thermostat attached to the blower housing was destroyed during the fire and was not testable. Examination of the automatic re-settable and one-shot high limit safety switches revealed both were damaged by the fire. The one shot high limit safety switch had been removed post-fire. The automatic resettable high limit safety device was in place at the 11 o'clock position of the heater housing. The automatic resettable high limit safety device was not testable due to its post-fire condition. A visual inspection of its contacts was conducted. There was nothing to indicate the contacts had welded together, thus defeating the protection provided by this safety device. The contacts did display evidence of repeated cycling. Based upon the physical evidence it was determined that the automatic resettable high limit safety switch had operated repeatedly over the lifetime of dryer use due to elevated temperatures behind the drum from a reduction of airflow within the dryer. A cause of this would be related to reduced airflow within the dryer. Causes of reduced airflow include exhaust restrictions, inadequate make-up air, large loads and defective internal seals, and any combination thereof.

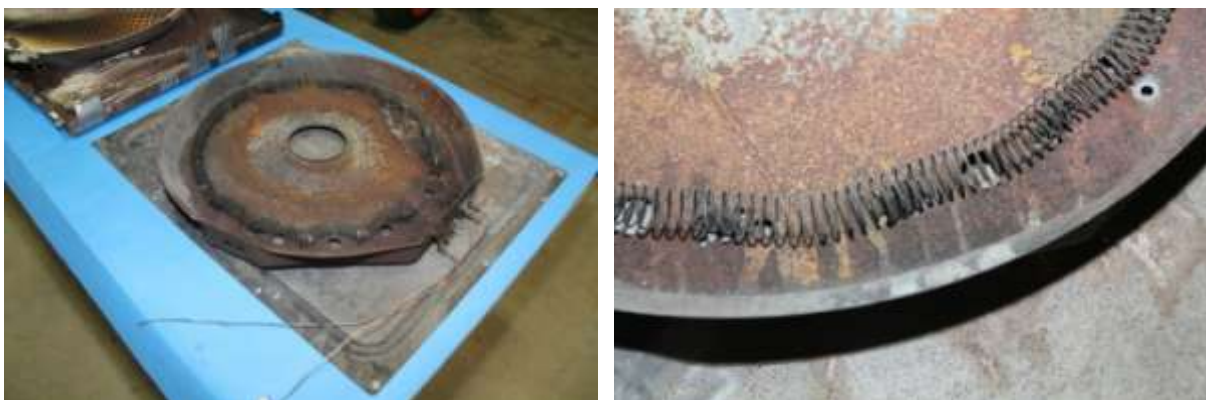
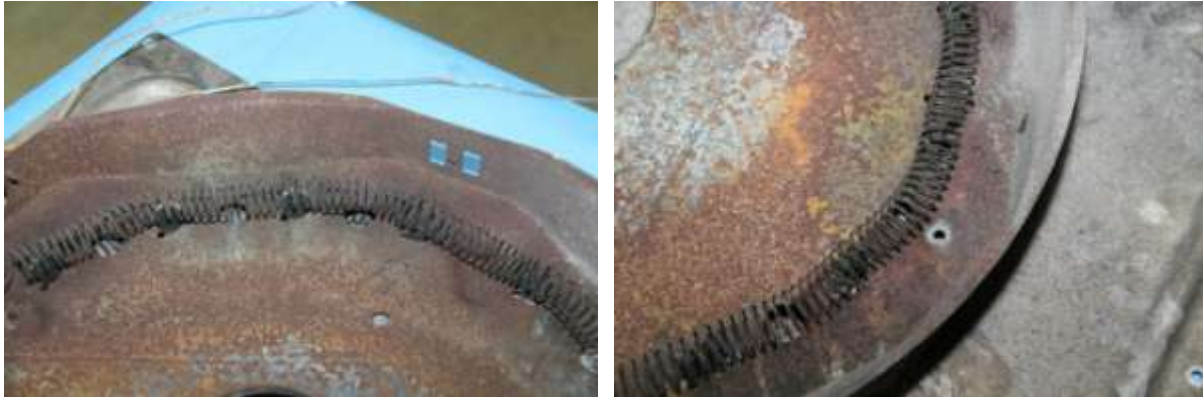
Heater Housing

Examination of the heater housing revealed normally mounted to the rear wall of the cabinet revealed that it had been removed during the prior evidence examination. The heater pan displayed evidence of heavy heat damage and oxidation. Examination of the heating element revealed the heating element was intact and showed no evidence of electrical activity. A resistance test was conducted on the coil and resulted in a reading of 11.8 ohms, which is a satisfactory resistance value for the heating element. All of the ceramic element standoffs used to secure the heating element in place and insulate it from the heater pan were in place. There was no evidence that the heating element had shorted to the heater housing or to the rear of the drum assembly. Any lint that may have been located in the heater pan was consumed during the fire.

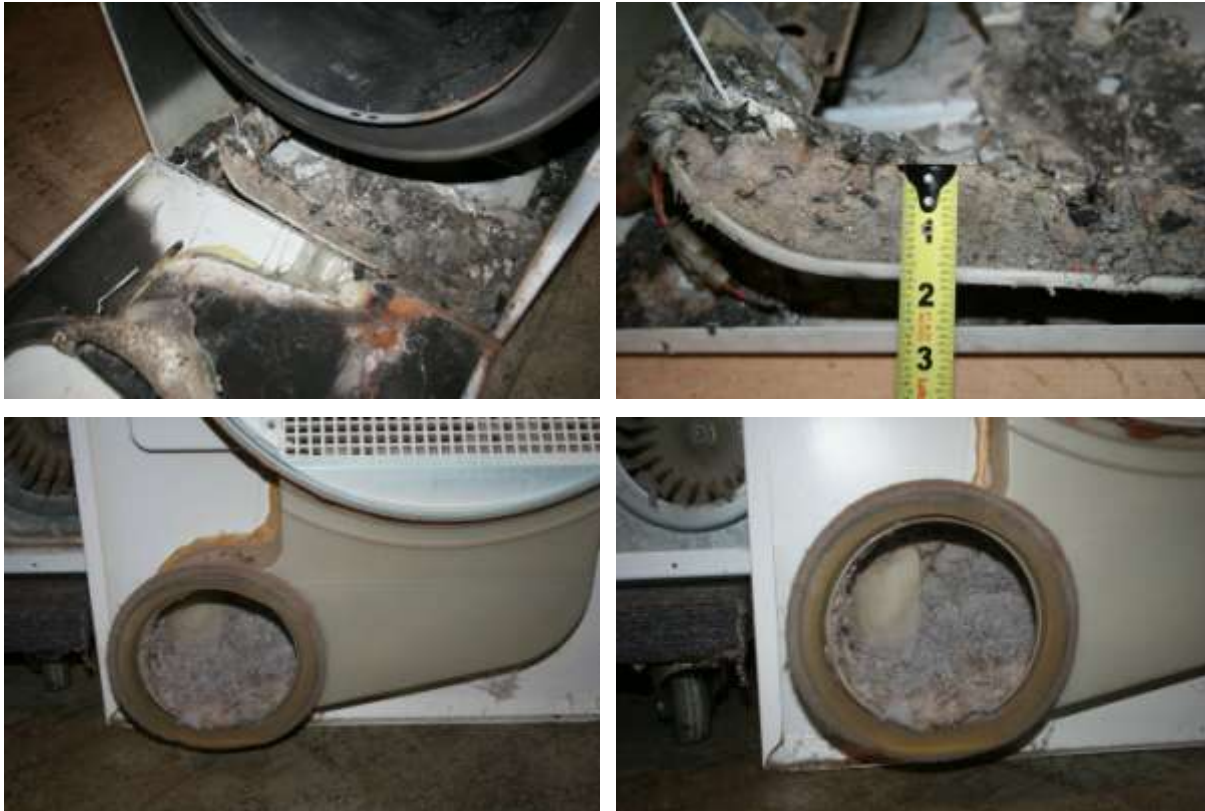
**Photos of Lint Accumulations in Exemplar Burned and Unburned Dryers
(At the Remains of the Trap Duct)**

restrictive elbow at the lower corner of the front panel. The adhesive used at the factory to glue the trap duct to the front panel remains tacky during its lifetime and any lint introduced will bond to the adhesive in the trap duct area. It is connected via a foam gasket to the blower assembly, which is also made from plastic and houses the fan impeller. If improperly installed, the foam gasket that forms the seal between the trap duct and blower housing can result in reduced airflow.

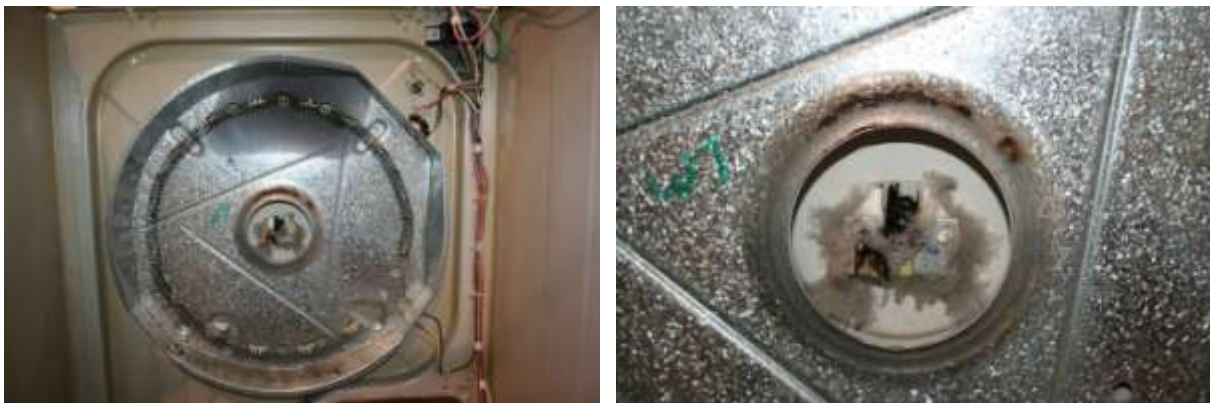
Photos of Lint Accumulations in an Exemplar Unburned Electric Dryer

detach from the rear of the drum and fall onto the heating element. In addition, this quantity of lint is an excellent source of secondary spread fuels that is in very close proximity to the heating element located directly behind the drum. The gas-fired dryers are equipped with a felt seal that surrounds the diffuser and forms a seal between the diffuser and the rear of the drum. The purpose of the seal in the gas dryer is to force the air to be drawn through the burner tube so the gas flame can heat the air as it is drawn into the diffuser and then is directed into the drum. Due to this seal forming an enclosure between the diffuser and rear of the drum, there are no openings through which any lint can escape. For this reason it is common to see large quantities of lint accumulated in the lower portion of the heat diffuser, immediately adjacent to the vertical heat duct that carries the heated air from the gas burner in the base of the cabinet. Though there are differences in the mechanisms by which the lint collects in the area behind the drum between the gas and electric designs, both allow for collection of lint in close proximity to the heat source which provides a higher probability of a lint fire occurring than alternative designs used in the industry.

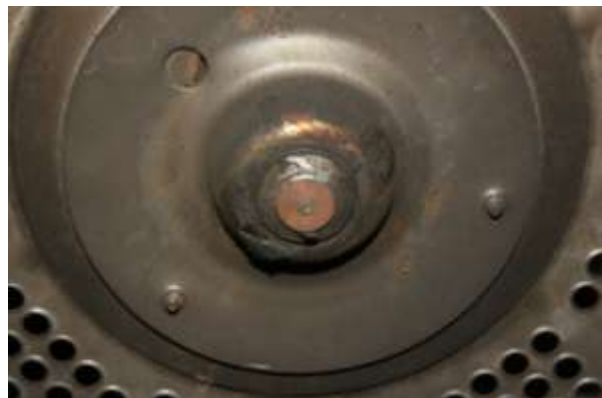
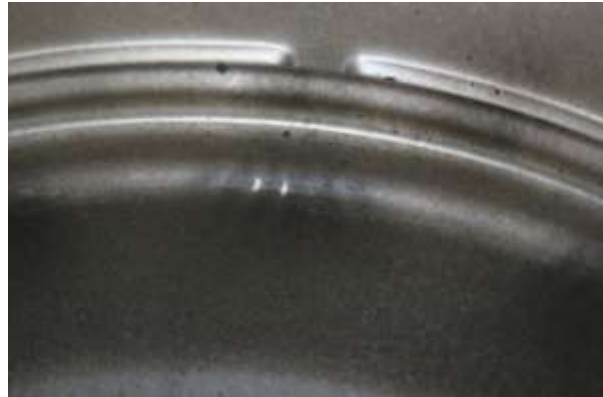
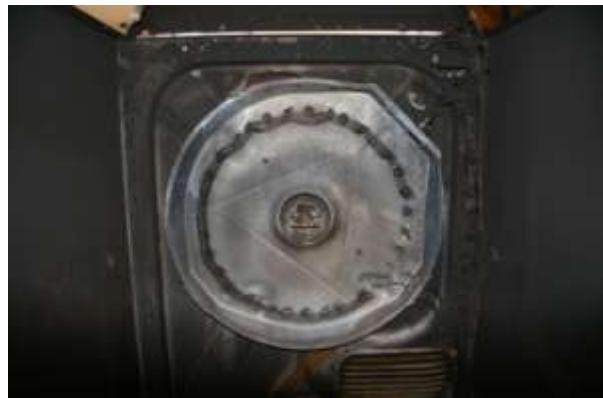
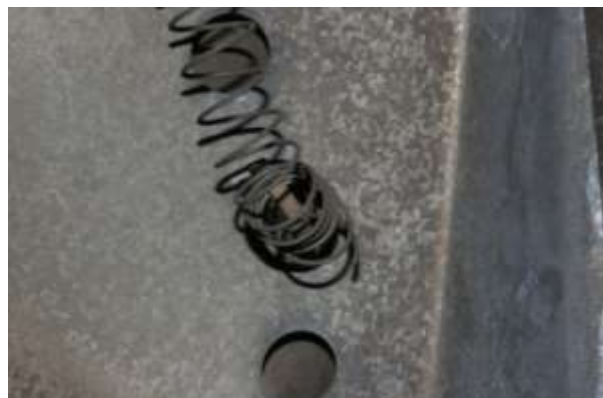
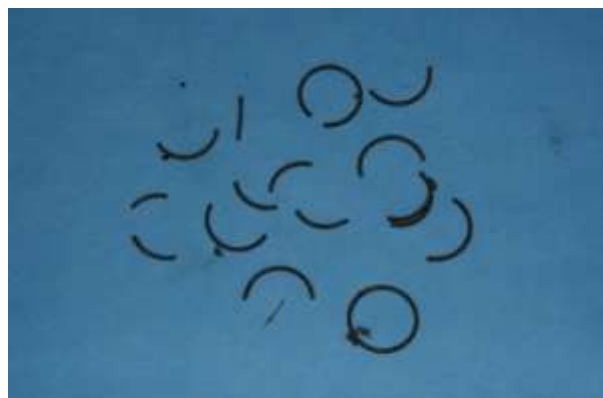
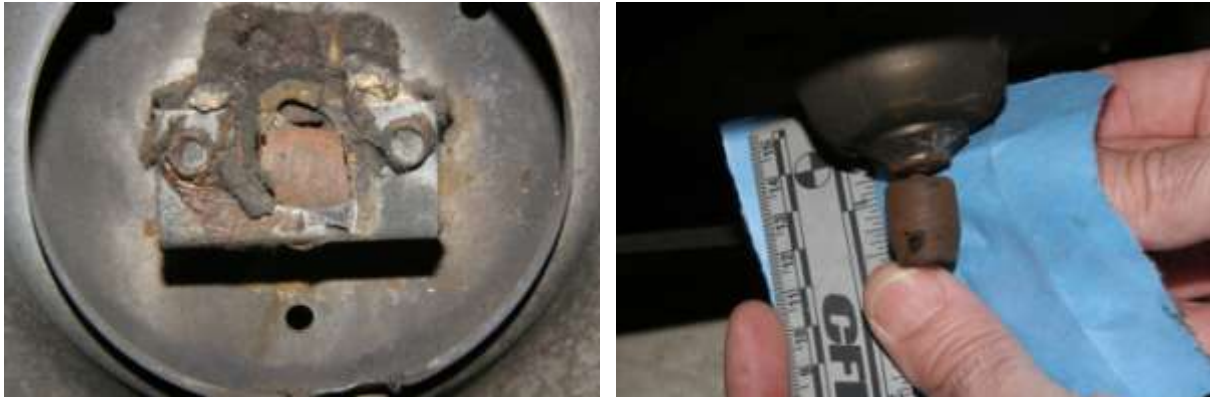
Example of Damage Related to a Bearing Failure

The first is a bearing failure that results in fire when the single rear bearing assembly that suspends the drum from the center of the heater housing fails, causing the rear of the metal drum and its clothing load to shift from its original position. When this occurs while the dryer is operating, the metal baffle/heat shield attached to the rear of drum contacts the energized heating element located approximately one inch from the rear of the drum, which results in a ground fault. This electrical short emits hot molten metal into the cabinet in the area at the rear of the drum. Any lint accumulated on the rear of the drum or within the cabinet can be ignited. The hot molten metal can also pass through the perforated ventilation openings in the rear of the drum and ignite the clothing load, particularly if the load is dry. The ability for the molten metal to be drawn into the rear of the drum is compounded by the negative pressure caused by the operating blower fan assembly, pulling air from the direction of the heating element behind the drum, into the clothing and toward the lint filter assembly at the front of the drum. It should be noted that other electric dryers of the other manufacturers' design types do not have their heating element located in this same location. Instead they are located in a metal duct in the cabinet below the drum. This eliminates the possibility of a bearing failure of any caliber to allow the drum to contact the heating element under any circumstances.

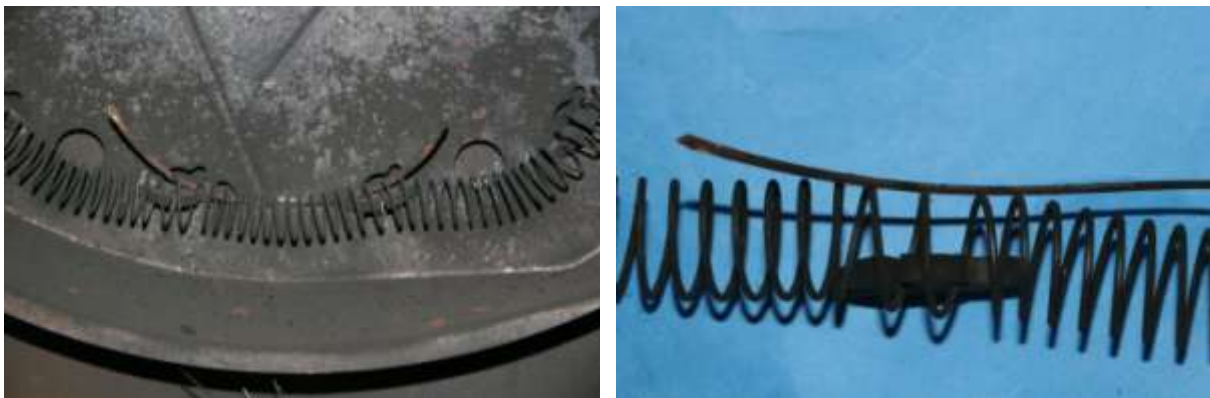
Example of Foreign Objects Contacting the Heating Element

The second fire cause scenario also relates to the heating element location directly behind the drum. Metallic objects from the clothing load can pass through the numerous ventilation perforations in the rear of the drum and enter the heater housing. If any of the items should contact the heating element while the heating element is energized, an electrical short can occur. The ground fault of the object between the heating element and any grounded metal component of the dryer, such as the heater housing or rear of the drum, would also result in the release of hot molten metal lint accumulated within the cabinet or into the air stream pulling the air from behind the drum into the lint accumulated at the rear of the drum or clothing in the interior of the drum. Ignition of lint and other combustibles can also occur when the foreign object forms a high resistance connection at the heating element. Items associated with this fire cause includes any clothes that contain metal objects, in particular under wire bras, or any small foreign objects accidentally left in the pockets of clothing, such as a bobby pins.

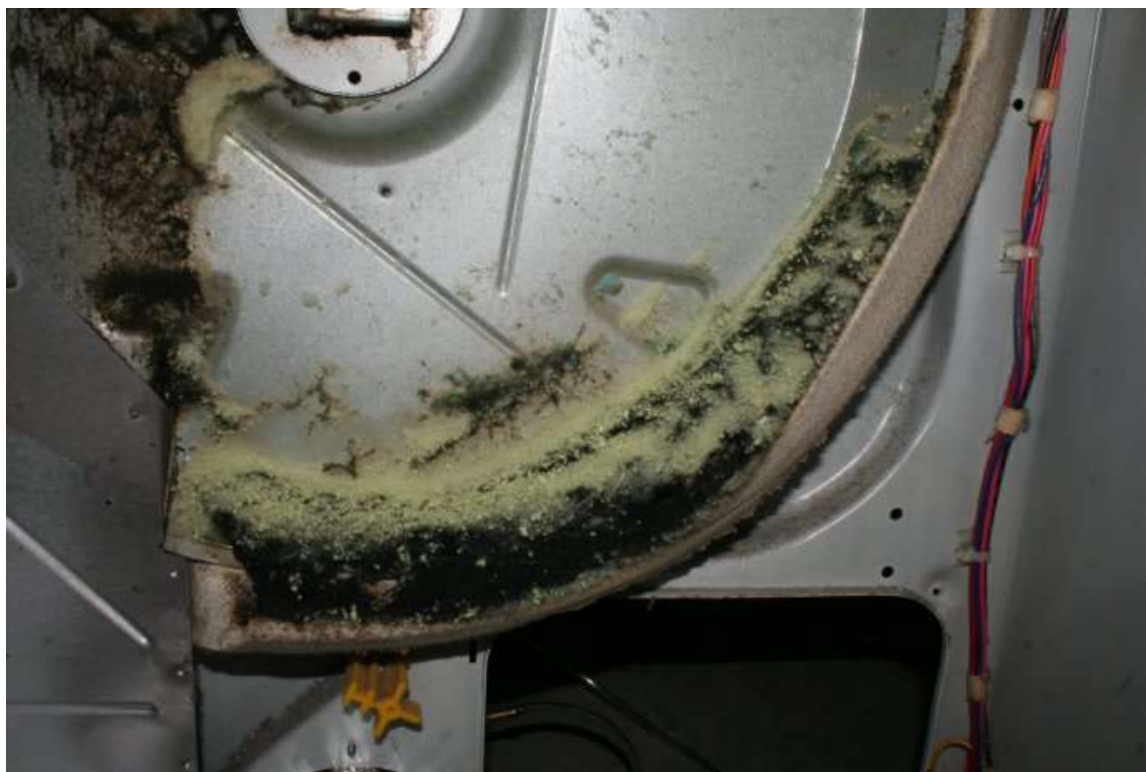
Photo 14: Used Electrolux Dryer – Burned and Fresh Lint in Heater Pan after Testing

Based upon this testing, it has been demonstrated that the ball-hitch design, used by Electrolux in their dryers, operated without a baffle and with an exhaust system back pressure of less than 0.75 inches of water column (specified in Electrolux's Installation Instructions as "acceptable") accumulate significant amounts of lint in between the heat source and the drum after only twenty loads of ten bath towels were washed and dried. The used Electrolux ball-hitch dryer collected even more lint, and a lint ignition fire occurred during the test. The RONCO 3 alternative still collected lint in the heater pan, but the guard prevented the lint from entering the heat duct and igniting. In contrast, the bulkhead design used by Whirlpool, Maytag, LG, Samsung and now Electrolux, was tested using the same parameters did not accumulate any lint in the path of airflow between the heat source and the drum.
